To: Stefan Galvez, California Department of Transportation

Date: November 3, 2009

RE: San Francisco-Oakland Bay Bridge East Span Seismic Safety Project – Self Anchored Suspension Span, T1 Temporary Access Trestle Pile Driving
Preliminary Results of Daily Bird Predation Monitoring for 11/02/2009

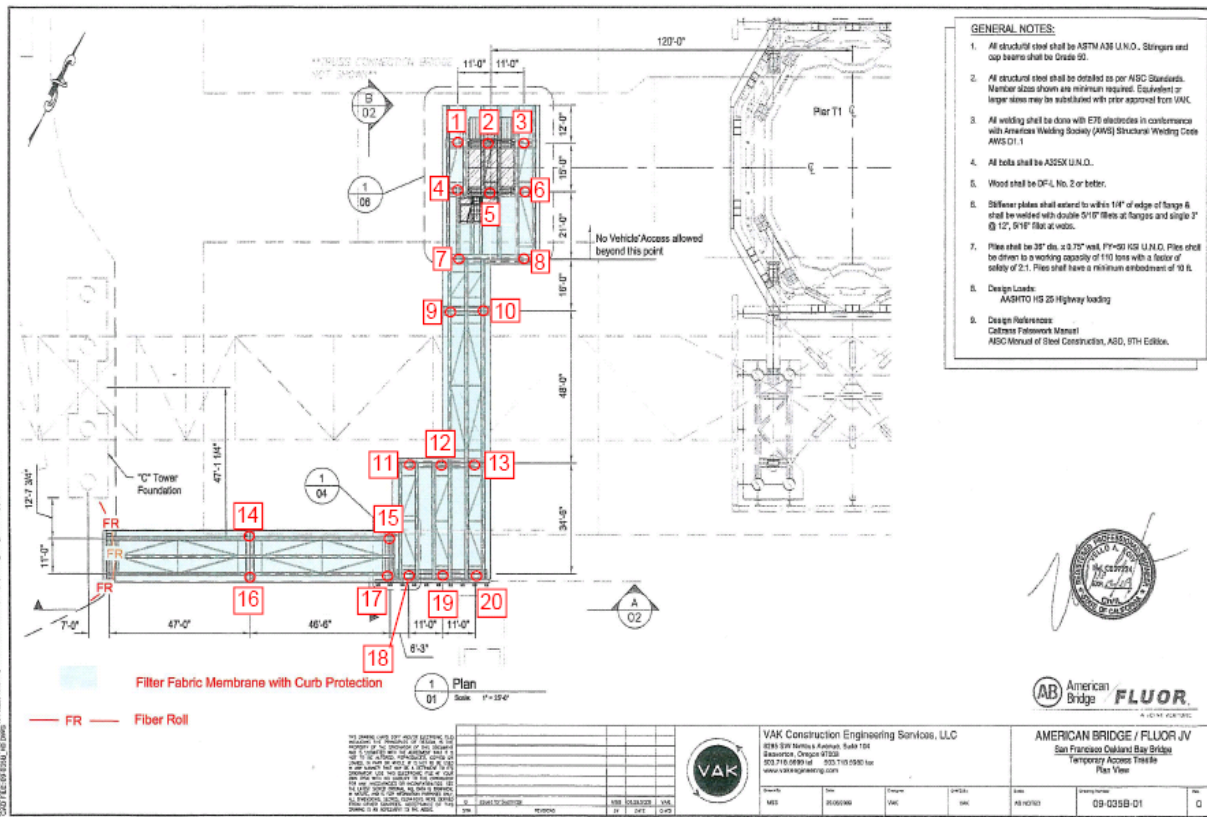
Figure 1.

The bird predation monitor was located on a boat in the immediate vicinity [within 200 meters (660 feet)] of the temporary access trestle pile driving located between Yerba Buena Island and Pier T1 (Figure 1). The monitor recorded birds' feeding activity on standardized data sheets throughout the monitoring period, including during the pile driving events and during the intervals between piles. If feeding was observed, one-minute counts of bird strikes were initiated. Those counts were repeated throughout the duration of the pile driving activity, as needed.

On November 2, 2009, a total of three (3) steel pipe piles of 36-inch diameter were driven with the Delmag D 32-30 diesel impact hammer. The piles were identified from Figure 1 as pile numbers 7, 8, and 10. Pile number 10 was driven from 0821 to 0825 hours, pile number 8 was driven from 1358 to 1402 hours and again from 1405 to 1407 hours, and pile number 7 was driven from 1433 to 1436 hours. The total duration of active pile driving was approximately thirteen (13) minutes. Table 1 shows the approximate periods of the impact driving, and the occurrence of bird feeding/activity/predation when observed.
