**RE:** San Francisco-Oakland Bay Bridge East Span Seismic Safety Project – Self Anchored Suspension Span, T1 Temporary Access Trestle Pile Driving  
Preliminary Results of Daily Bird Predation Monitoring for 11/04/2009

This memorandum provides preliminary results of bird predation monitoring conducted on November 4, 2009 during pile driving for the temporary access trestle. The monitoring was conducted in compliance with the requirements outlined in the Final Hydroacoustic Monitoring Plan for Driving of Temporary Access Trestle Piles for the Self-Anchored Suspension Span (October 2009).

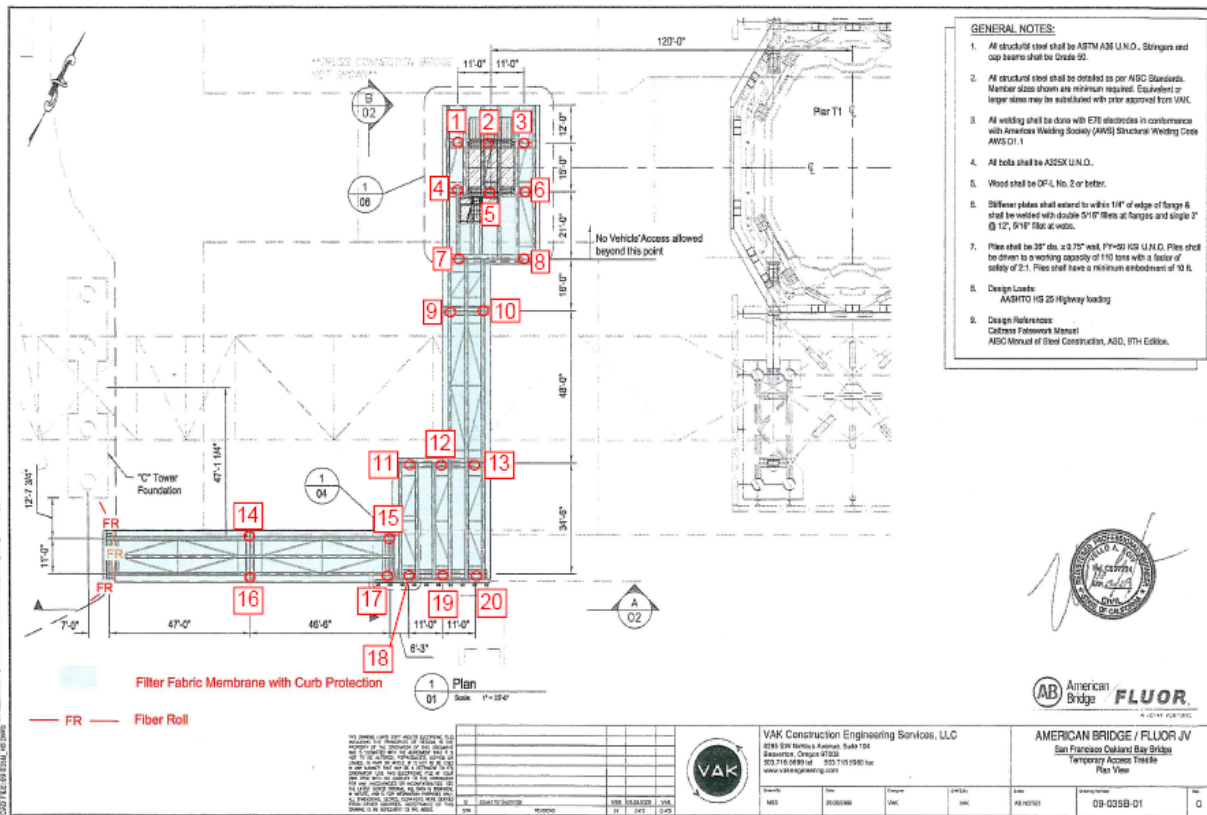
**Figure 1.**

The bird predation monitor was located on a boat in the immediate vicinity [within 200 meters (660 feet)] of the temporary access trestle pile driving located between Yerba Buena Island and Pier T1 (Figure 1). The monitor recorded birds' feeding activity on standardized data sheets throughout the monitoring period, including during the pile driving events and during the intervals between piles. If feeding was observed, one-minute counts of bird strikes were initiated. Those counts were repeated throughout the duration of the pile driving activity, as needed.

On November 4, 2009, a total of three (3) steel pipe piles of 36-inch diameter were driven with the Delmag D 32-30 diesel impact hammer. The piles were identified from Figure 1 as pile numbers 4, 5, and 6. Pile number 6 was driven from 0847 to 0853 hours, pile number 5 was driven from 0917 to 0921 hours, and pile number 4 was driven from 0957 to 1000 hours. The total duration of active pile driving was approximately thirteen (13) minutes. Table 1 shows the approximate periods of the impact driving, and the occurrence of bird feeding/activity/predation when observed.
