RE: Caltrans Bay Bridge Project - SAS Temporary Pile Driving
Incidental Bird Predation and Fish Monitoring Notes for 03/19/2009

*SFOBB SAS Pile Driving
Bird Predation Memorandum*

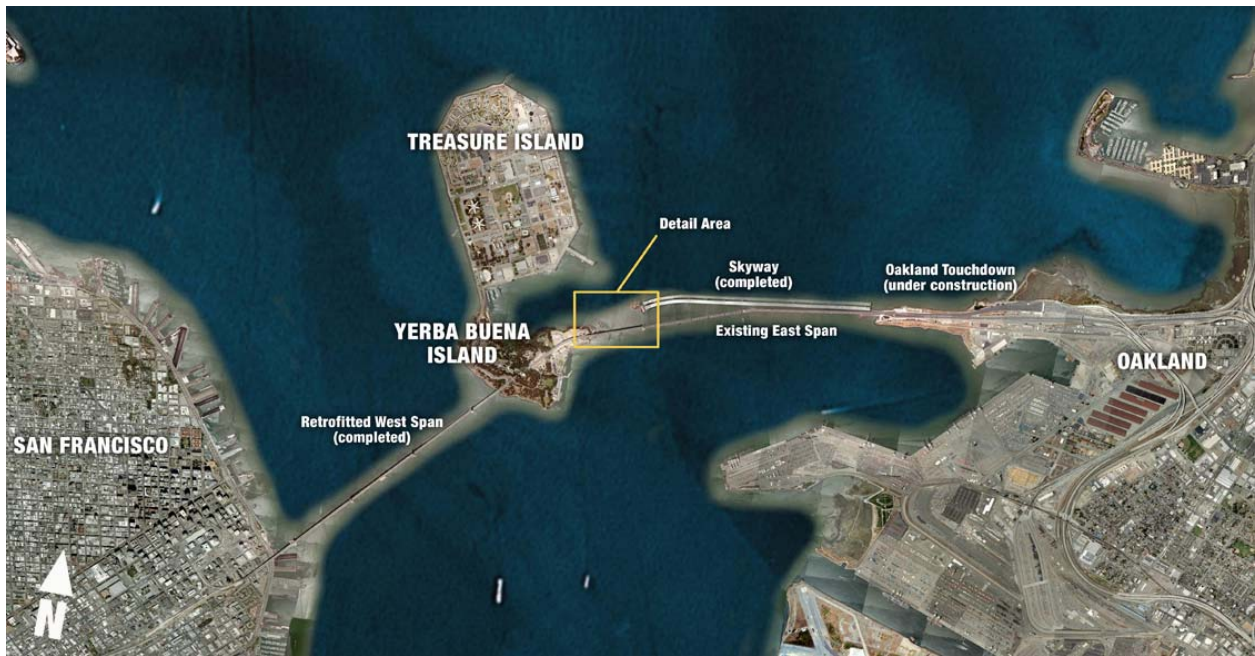
Figure 1. SFOBB East Span Seismic Safety Project Area

To improve the seismic safety of the San Francisco-Oakland Bay Bridge (SFOBB), the California Department of Transportation (Caltrans) is replacing the existing East Span with a new bridge immediately to the north (Figure 1). As part of the construction for the Self-Anchored Suspension (SAS) portion of the project, it is necessary to build temporary towers. These temporary towers, Temporary Towers D, F and G are marine based and require driving of temporary piles to support the SAS portion of the bridge during construction (Figure 2).
