MEMORANDUM

SUBJECT: MARINE MAMMAL OBSERVATIONS MEMO

OBSERVATIONS DURING EAST SPAN PROJECT PILE DRIVING AT TEMPORARY TOWER G ON APRIL 30 AND MAY 1, 2009

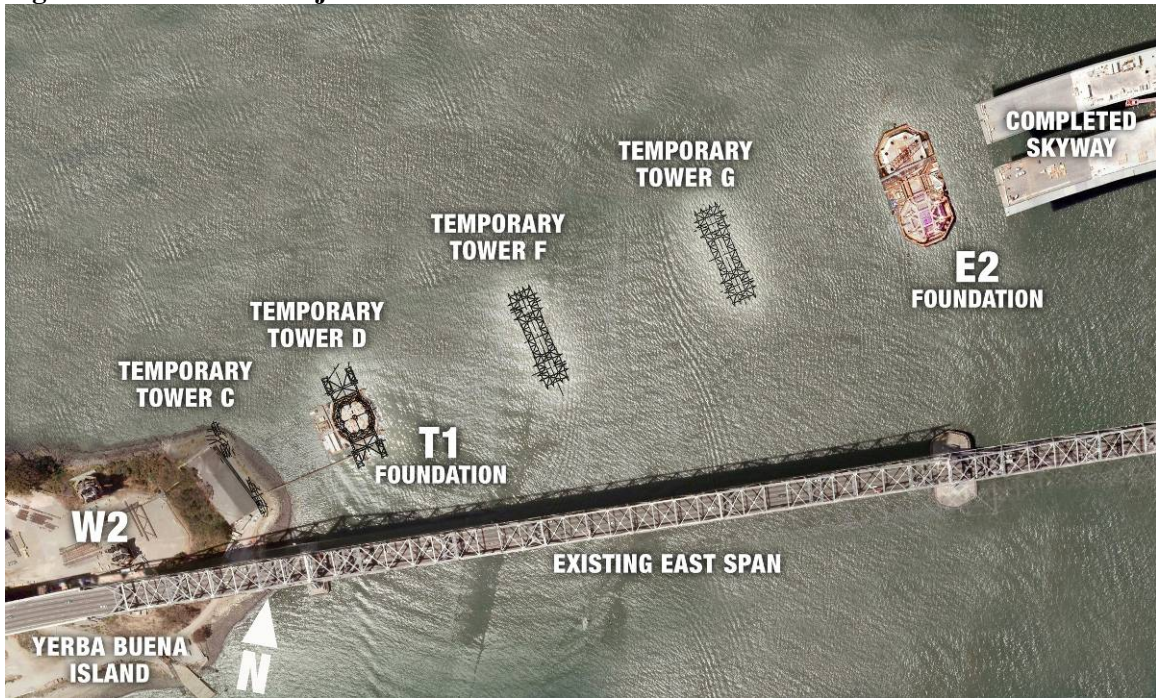
Figure 2: Detail SAS Project Area

The California Department of Transportation (Department) is in the process of replacing the East Span of the San Francisco-Oakland Bay Bridge (SFOBB) with a new bridge immediately to the north of the existing span (Figure 1). Construction of the San Francisco-Oakland Bay Bridge East Span Seismic Safety Project (SFOBB Project) is a multi-year effort that will involve a number of construction activities on land as well as in San Francisco Bay. As part of the construction for the Self-Anchored Suspension (SAS) portion of the project, it is necessary to build temporary towers. These temporary towers, Temporary Towers D, F and G are marine based and require driving of temporary piles to support the SAS portion of the bridge during construction (Figure 2).

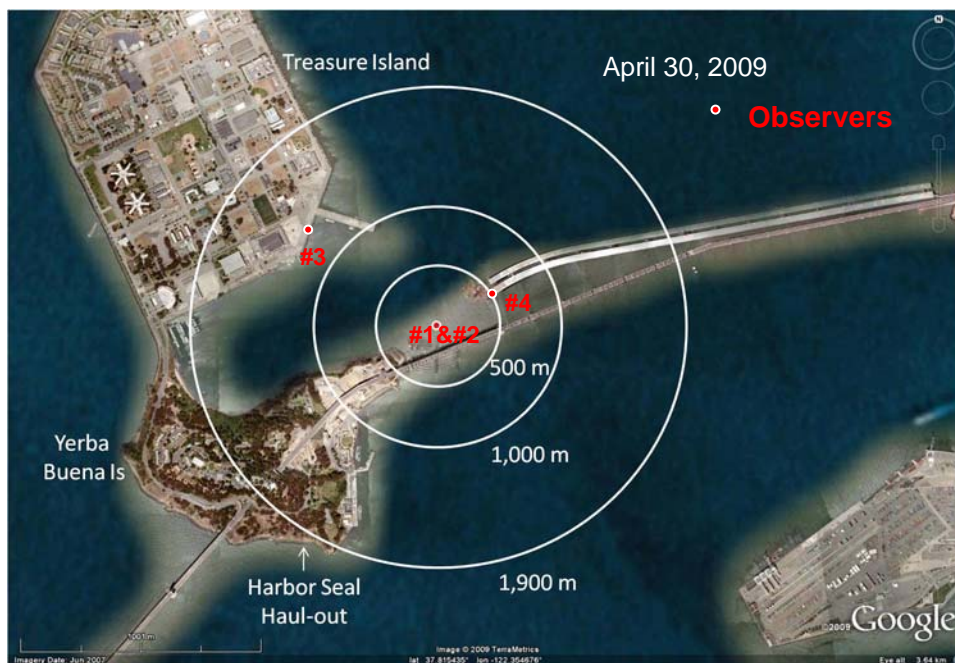
Figure 3: SAS temporary tower project area with 500 meter (preliminary), 1,000 meter (160 dB impact), and 1,900 meter (120 dB vibratory) MMSZs and marine mammal monitor observation sites for April 30, 2009.

Monitoring was conducted by NOAA-Fisheries-approved marine mammal observers on April 30 and May 1, 2009 in the vicinity of Temporary Tower G of the SAS. A 1,900-meter (6,234-foot) MMSZ was used for the vibratory pile driver to correspond with the 120 dB isopleth described above (Figure 3& 4).

On April 30, 2009: Observer #1 and #2 were located on the pile driving barge at Temporary Tower G, Observer #3 was located on the southeast end of Treasure Island, and Observer #4 was located on the west end of the new Bay Bridge, as shown on Figure 3. Pile driving was conducted on six piles from 1455 to 1533 hours using the vibratory pile driver. Observations were made from 1300 to 1610 hours.

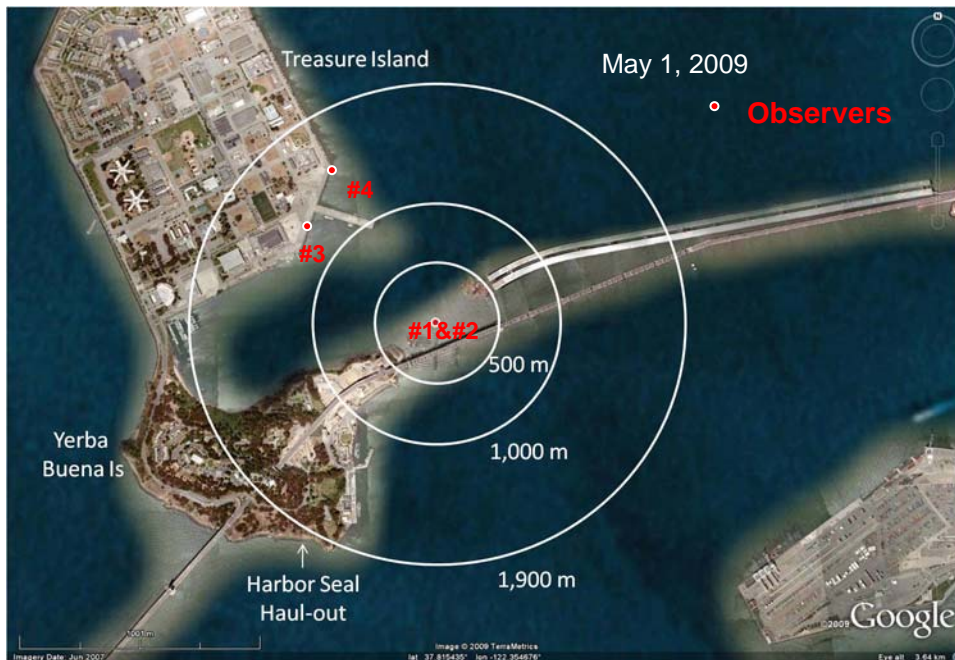
Figure 4: SAS temporary tower project area with 500 meter (preliminary), 1,000 meter (160 dB impact), and 1,900 meter (120 dB vibratory) MMSZs and marine mammal monitor observation sites for May 1, 2009.

On May 1, 2009: Observer #1 and #2 were located on the pile driving barge at Temporary Tower G and Observers #3 and #4 were located on the southeast end of Treasure Island, as shown on Figure 4. Pile driving was conducted on eight piles from 1453 to 1549 hours using the vibratory pile driver. Observations were made from 1200 to 1620 hours.
